Product Bulletin

ProGen® Upright Power Cord Care Reminder

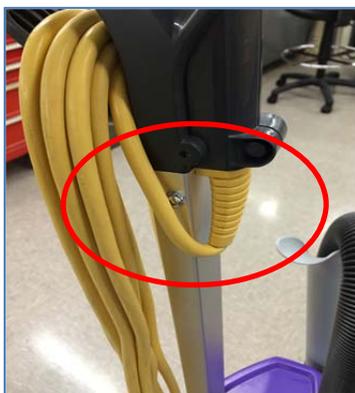
PHOTO 1

- 1) The cord should be wrapped around the bottom cord storage hook first and then directed upward and wrapped around the top hook. The pattern would continue until the cord is fully stored on the vacuum. This method cares for the cord in such a way as to reduce stress on the jacket and its internal conductors while not in use. If the cord storage process begins by wrapping over the top hook, especially immediately after long use, when the cord temperature is higher, it creates a sharp bend and can break the cord's internal conductors. *See Photo 1 below.*

EXAMPLE OF HOW NOT TO SECURE THE POWER CORD:

We have received reports of the ProGen upright power cord separating at the strain relief as well as cord jacket failure at the point where the cord is joined with the strain relief over-mold. Testing has shown the cause of this type of damage as a result of extreme bending of the cords over time contrary to their design.

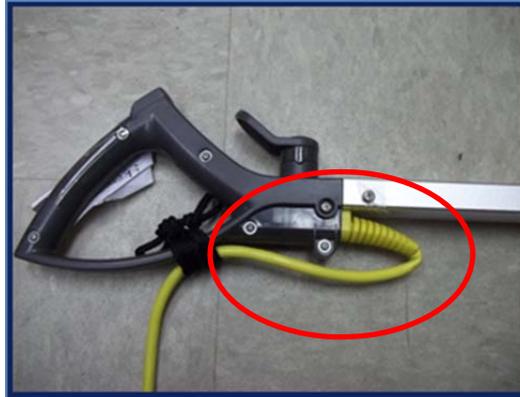
PHOTO 2

- 2) Forcing the cord and strain relief in an extreme direction/position. One vacuum recently observed had the cord bent backwards and secured to the handle. The internal conductors of the cord were damaged at the point where the cord is joined with the strain relief, which resulted in a short and the vacuum inoperable. Cords should not be forced into such an extreme position. *See Photo 2 below.*

EXAMPLE OF HOW NOT TO SECURE THE POWER CORD:

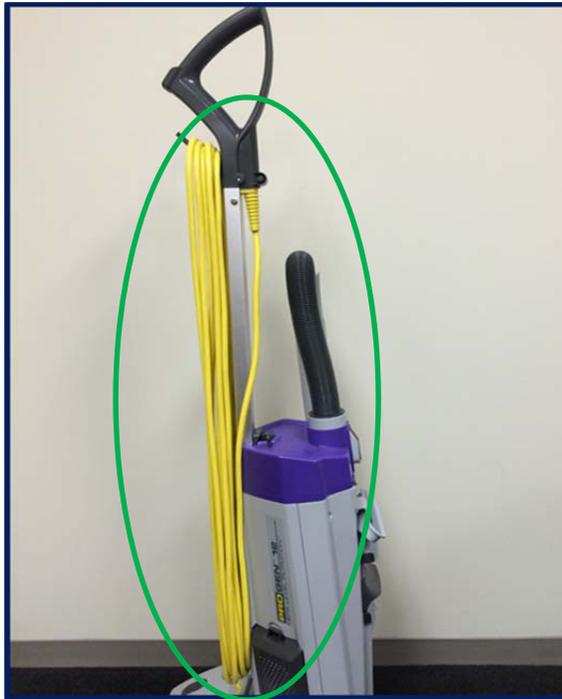
CORRECT CORD STORAGE AND DIRECTION OF WRAP:
